INSTALLATION INSTRUCTIONS

PRT[®] (ES)

PRT® (ES) combines the proven benefits of heat shrinkable tubing, a hot-melt adhesive and the ease of installation using Zippertubing's wrap-around heat shrink products. This PRT® (ES) is designed to provide "Water Blocking"; an environmentally sealed repair patch to wires and cables.

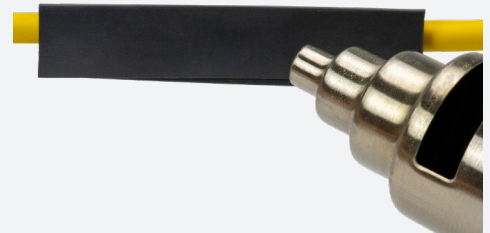
Photo 3: Nozzle focused near tubing center on overlap seam

PRT® (ES) tubing requires the use of a heat gun with a temperature setting of 194°F minimum. For best results, use a heat gun with a 3/8" reducer nozzle that will localize the heat stream ([Photo 3](#)). Generally, a heat gun temperature of 302°F is sufficient to shrink the PRT® (ES-135) material and allow the hot-melt adhesive to flow. 257°F is sufficient to shrink PRT® (ES-100).

1. Begin shrinking the PRT® (ES) tubing by directing the heat source at the adhesive overlap seam area near the center of the repair tubing ([Photo 3](#)). Apply heat to the adhesive overlap area only! The overlap area will tend to curl up into a "U" shape as it is heated. Continue to apply heat in short bursts to this area until the surrounding tubing begins to shrink and pull the "U" shape back down flat. Do not be afraid to apply extra heat to the overlap area, as it will take extra time for the inside layer of the overlap to begin to shrink since this area is double thick. Do not be alarmed if the outer layer of the overlap flap tends to lift off the adhesive and curl back slightly during initial heat exposure. With continued heating this lifted area will generally lay back down on its own, if not, lightly tap the lifted edge as necessary with a wooden popsicle stick. Use caution when touching the tubing as it will be hot and sticky. Shrink the entire overlap seam length before attempting to recover the remaining tubing ([Photo 4 - located on the following page](#)).

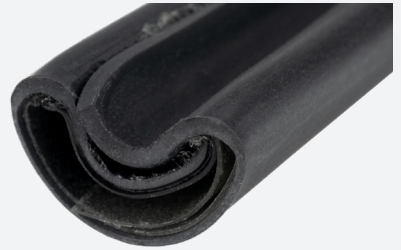
Photo 4: Overlap seams curled up prior to full shrinkage.

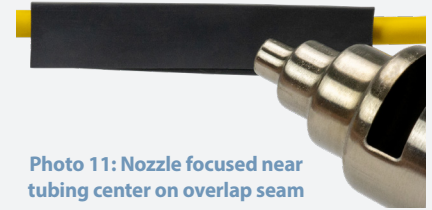
Photo 11: Nozzle focused near tubing center on overlap seam

PRT® (ES) tubing requires the use of a heat gun with a temperature setting of 194°F minimum. For best results, use a heat gun with a 3/8" reducer nozzle that will localize the heat stream (Photo 11). Generally, a heat gun temperature of 302°F is sufficient to shrink the PRT® (ES) material and allow the hot-melt adhesive to flow.

1. Begin shrinking the PRT® (ES) tubing by directing the heat source at the adhesive overlap seam area near the center of the repair tubing (Photo 11). Apply heat to the adhesive overlap area only! The overlap area will tend to curl up into a "U" shape as it is heated. Continue to apply heat in short bursts to this area until the surrounding tubing begins to shrink and pull the "U" shape back down flat. Do not be afraid to apply extra heat to the overlap area, as it will take extra dwell time for the inside layer of the overlap to begin to shrink since this area is double thick. Do not be alarmed if the outer layer of the overlap flap tends to lift off the adhesive and curl back slightly during initial heat exposure. With continued heating this lifted area will generally lay back down on its own, if not, lightly tap the lifted edge as necessary with a wooden popsicle stick. Use caution when touching the tubing as it will be hot and sticky. Shrink the entire overlap seam length before attempting to recover the remaining tubing (Photo 12).

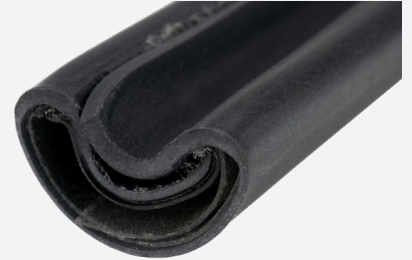
Photo 12: Overlap seams curled up prior to full shrinkage.
