# Airborne Wire & Cable Repair Using 135°C PRT-ES® Tubing

By VERNON L. SHRADER Director of Engineering

Presented April 20, 2011 2011 Aircraft Airworthiness & Sustainment Conference, Session: EWIS A San Diego, California

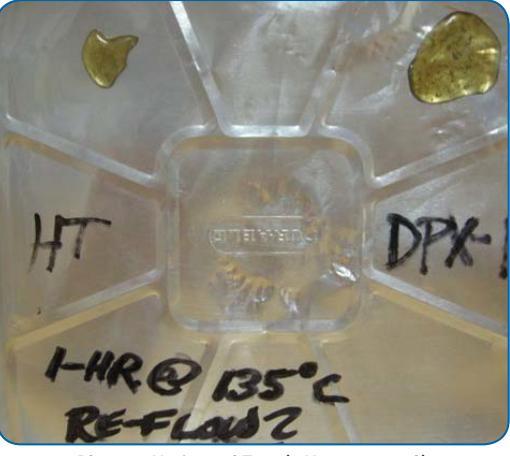
Photo 1: Horizontal Tray (1-Hour @ 135°C)

After the molten samples had cooled to room temperature, the aluminum tray was placed in an oven at 125+/1°C. After one hour of heat soak, both adhesive masses were probed using a metal rod to determine the degree of softness. The ES tape sample was soft and sticky. The metal probe easily penetrated the adhesive mass and created strings of material sticking to the rod upon removal. The HT adhesive was firm, could not be penetrated by the rod and no strings of material clung to the metal rod. The procedure was repeated with the oven temperature raised to 135+/1°C (*Photo 1*). The ES material exhibited similar results as seen at 125°C but the HT material was still firm and the probe would not penetrate the adhesive mass. It was possible to create shallow marks in the adhesive surface but there were no strings or signs of the material sticking to the metal rod.

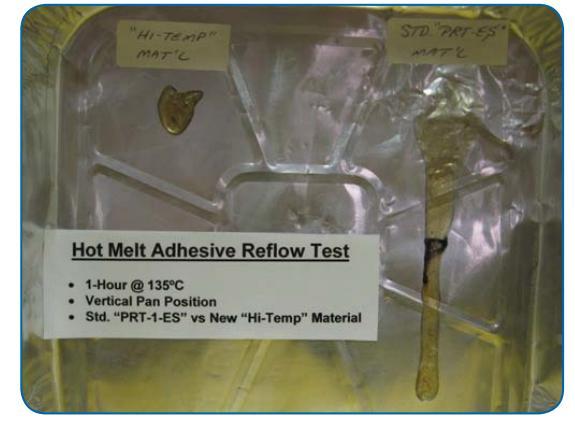
Photo 2: Vertical Tray (1-Hour @ 135°C)

The aluminum tray was returned to the 135+/1 °C oven with the tray orientated in a vertical position to determine if the adhesive would flow or retain their shape? Upon removal it was evident that ninety-five percent of the ES material puddle had flowed and become a streak six to seven inches long. The original puddle shape was gone and only a thin film of adhesive remained. There was no evidence of the original 1/8" thick raised mound of adhesive where the flow had started. Conversely, the HT material had not flowed and it retained its original puddle shape and the 1/8" thick mound of adhesive. *(Photos 2, 3 & 4)*

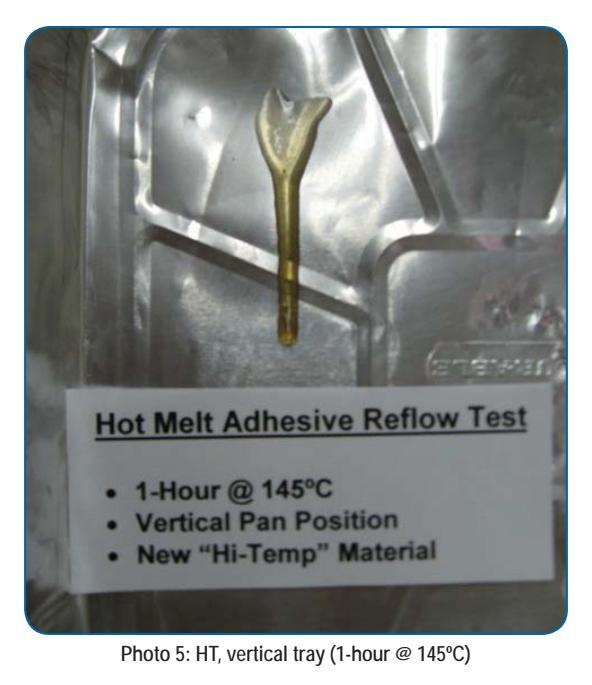
This process was repeated with the temperature raised to 145+/1 °C. Upon removal it was evident that the HT adhesive had finally reached its flow temperature. Approximately fifty percent of the HT material mass had begun to flow down the pan several inches *(Photo 5)*. It is interesting to note that at 145°C the entire HT adhesive puddle had not disappeared, a distinctive "V" shape was visible within the puddle inferring that it had reached its flow temperature, but still retained some degree of pastiness.

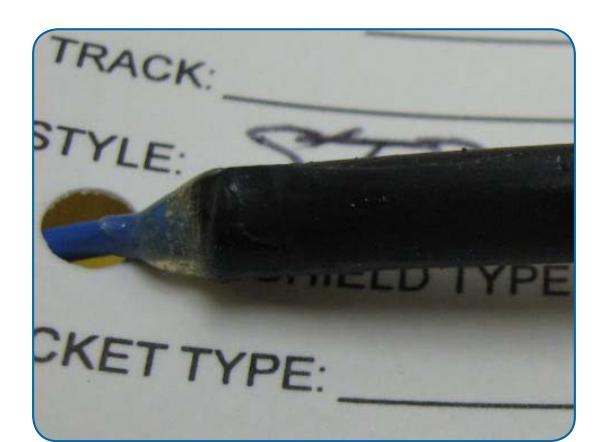
Photo 7: Large ES fillet

Fabrication of the PRT-1-ES repair sleeves using the standard ES adhesive yielded finished assemblies with large, bulbous adhesive fillets at the ends (Photo 7). Samples created using the HT adhesive required an additional 30-60 seconds of heat exposure to allow the adhesive to flow, plus an additional 30 seconds to create small tapered adhesive fillets at the ends. The resulting HT adhesive fillets were smaller and much less pronounced than those created using the ES adhesive (Photo 8). The additional heat-soak time was required because all samples were fabricated using the same heat gun temperature settings (140-160°C). Zippertubing does not recommend increasing the air stream temperature when using HT adhesive because this could result in blistering the polyolefin tubing material. Assembly time increased approximately 1-2 minutes using the HT adhesive. The HT adhesive assemblies exhibited several processing advantages over the original ES system. First, the end fillets can be dressed easier since the HT adhesive does not flow as easily. The molten material is more localized and has less of a tendency to be blown around the wire by the air stream. Second, ruptures at the tubing's overlap seam do not occur as easily because the adhesive is not expanding and bubbling as much inside the tubing. The overall result is that the HT adhesive reacts slower to heat and is more controllable during the installation process.

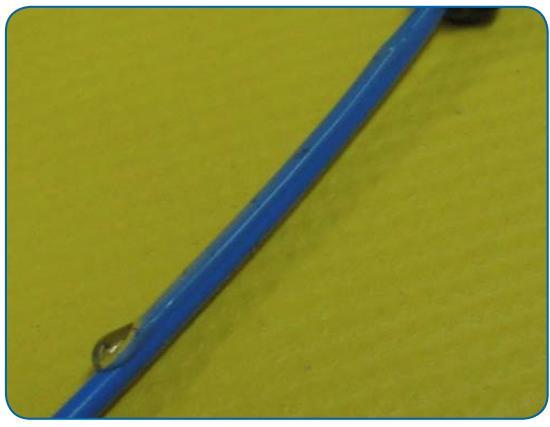
Photo 9: ES flow (4-Hours @ 135°C)

The test was repeated with the second set of six samples except the heat exposure duration was increased from one to four hours. *Photo 9 & 10* show the potential adhesive flow and repair sleeve slippage of the original ES adhesive when exposed to 135°C temperatures. Results were the same for both the one and four hour exposure samples. *Photos 11 A & B* illustrate the lack of any change to the HT sample sleeves. Fillet shapes and sleeve position on the wire did not change in any test sample for either the one or four hour exposures.
